CASE STUDY

CERTA-LOK® PVC PIPE OFFERS TWO-DAY AERIAL INSTALLATION FOR MUCH-NEEDED POTABLE WATER DELIVERY

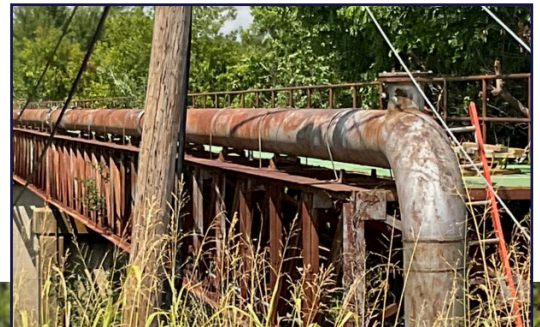
ORIGINAL STEEL WATER PIPELINE

In February of 2021, an 18-inch steel water pipeline installed along a 600-foot aerial crossing over the North Canadian River suffered a number of cracks during a fierce snowstorm. The cracks put the water line out of service until repairs could be started that summer. Water delivery to the west side of town was still possible with the line out of operation, but it was less than ideal. Summer arrived and the repair process was underway. With the old steel pipe pressurized, the team identified the location of the leaks. The pipe was then de-pressurized to install the first clamp and re-pressurized to test the repair. Using this process, seven repair clamps were installed to the aerial line with the pipe continuing to leak, at this point it was decided no further restoration attempts would be made. The city moved forward with approving a project to replace the damaged line and Project WC-1022 was scheduled for the 2023 construction season. The new design outlined installation of the pipeline under the North Canadian River instead of replacing the line in the same aerial position, over the river, exposed to the elements. There was still a need to address the current water demand and the team reviewed an immediate and speedy solution for an emergency repair.

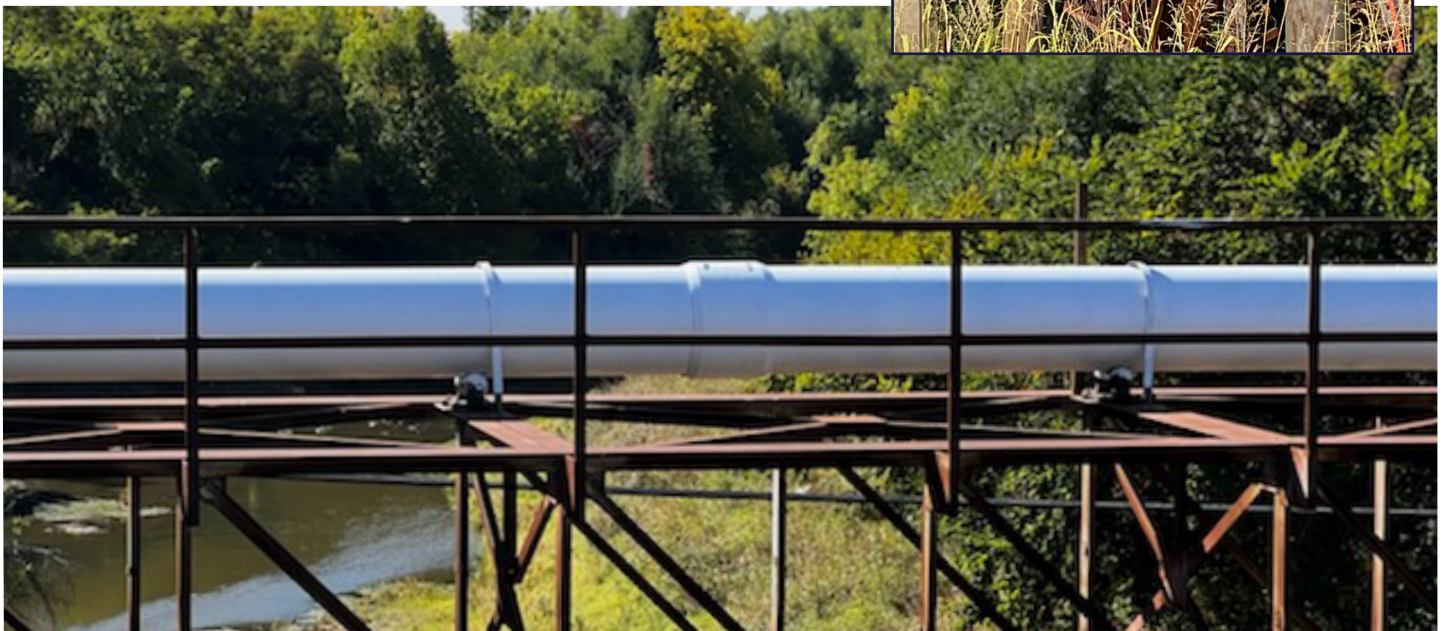
*AFTER – 18” CERTA-LOK® FINISHED INSTALLATION
SHOWN HERE PAINTED FOR UV PROTECTION*

The simplicity of Wade Vakulick’s plan resulted in the 600 feet of pipe being installed in less than two days. The crew started swinging the new pipe onto the bridge in the afternoon and finished the following morning. Once all the pipe was in place, the workers manually assembled the pipe-to-coupling joints. Finally, the nylon spline was inserted into the spline insertion holes completing the “spline lock” and the joint was fully restrained.
